# In situ Observation of Li Deposition-Induced Cracking in Garnet Solid Electrolytes

Jun Zhao, Yongfu Tang, Qiushi Dai, Congcong Du, Yin Zhang, Dingchuan Xue, Tianwu Chen, Jingzhao Chen, Bo Wang, Jingming Yao, Ning Zhao, Yanshuai Li, Shuman Xia, Xiangxin Guo, Stephen J. Harris, Liqiang Zhang\*, Sulin Zhang\*, Ting Zhu\*, and Jianyu Huang\*

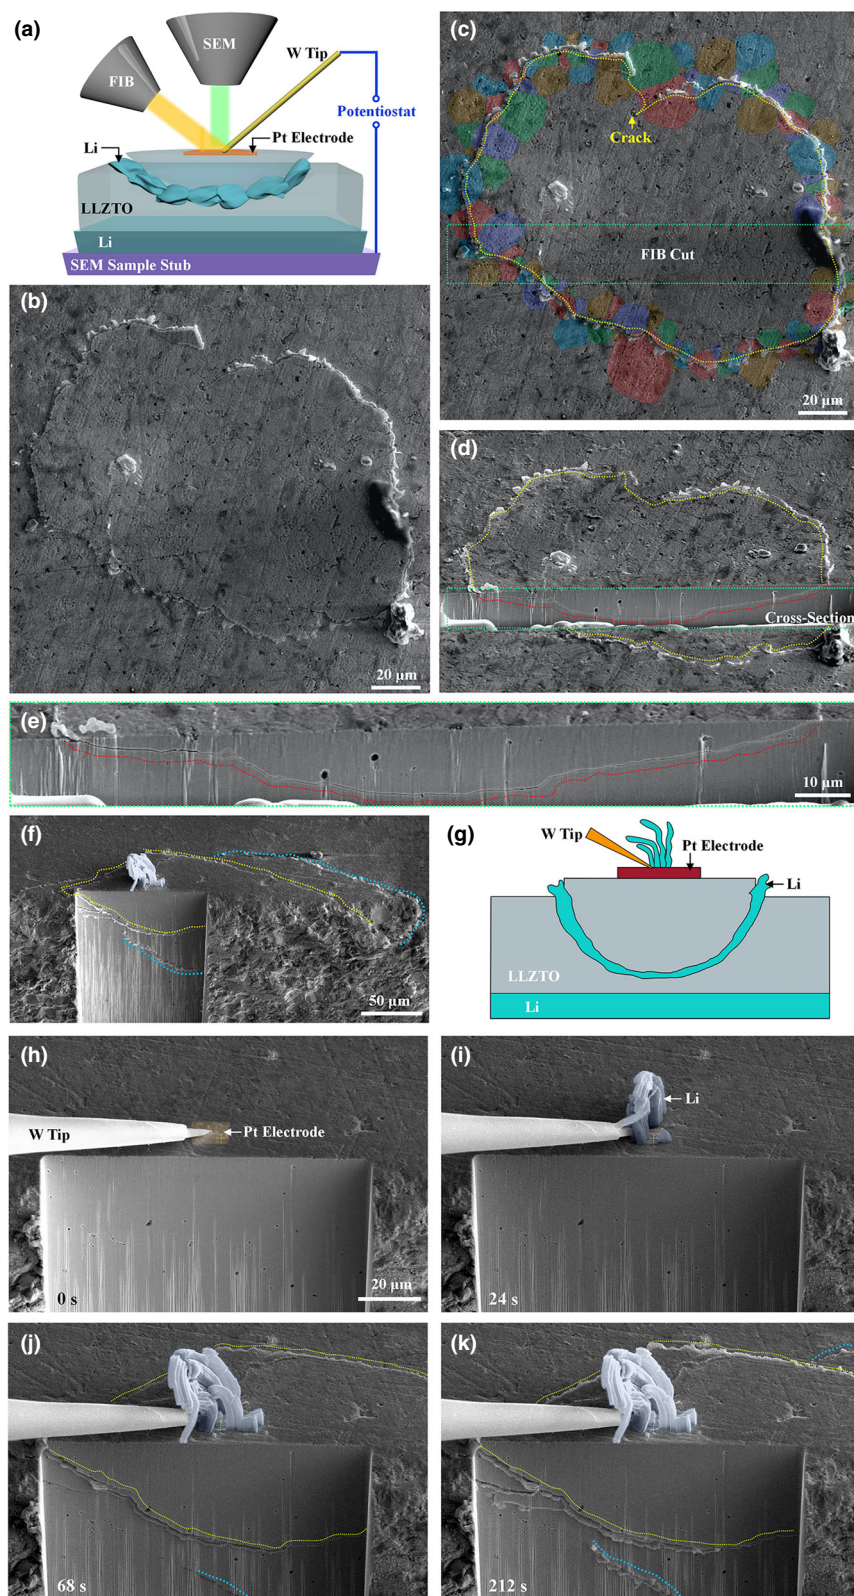
**Figure 1.** In situ observation of Li deposition and cracking in SEs by a mesoscale FIB-SEM-based SSB, showing two sets of time sequence images in (a–e) and (f–k) for the formation of bowl-shaped cracks followed by Li filling in cracks. a) Schematic of the in situ battery testing, resulting in the formation of a bowl-shaped crack. A Pt electrode was deposited on the top surface of the LLZTO SE. Li or liquid GaInAg metal was used as the counter electrode. b, c) SEM images showing the formation of a bowl-shaped crack in the LLZTO SE. c) is the same as b), except that the colored grains around the bowl-shaped crack line on the LLZTO surface are sketched and overlaid on the real grains, showing the crack path through grain interiors. d) A cross-sectional view of the bowl-shaped crack, where the yellow and red dotted lines outline the bowl-shaped crack on the top surface and cross section, respectively. e) Magnified view of the bowl-shaped crack on the cross section from FIB milling, corresponding to the region boxed by green dotted lines in (d). f–k) In situ observation of the dynamic formation of a bowl-shaped crack and Li filling. f) A full view of the bowl-shaped crack, showing the crack contour on both the top surface and cross section. Li dendrites formed at the Pt electrode pad before the occurrence of LLZTO cracking. g) Schematic of the Li dendrites, bowl-shaped crack, and filled Li in the crack. h) LLZTO was milled by FIB to expose its side surface. h–k) Time-lapse images showing the formation of a bowl-shaped crack. A dendrite appeared near the Pt electrode (i) and then grew (j); the formation of two bowl-shaped cracks is shown in (j, k). The growth of dendrites appeared to cease once the bowl-shaped crack emerged by comparing (j) and (k).

Our experiments were conducted in an FIB-SEM system, where a two-terminal electrochemical device was constructed to enable in situ testing of a mesoscale battery. LLZTO with the cubic crystal structure (Figure S1, Supporting Information) was synthesized via hot pressing at a pressure of 20 MPa and a temperature of 1150 °C for 1 h under Ar atmosphere. An LLZTO disk with a diameter of 12 mm and thickness of 1 mm was placed on a Li metal electrode supported by an SEM sample stub, which was connected to one terminal of an external power supply (Figure 1a). On the top surface of the LLZTO disk,

a Pt electrode pad of  $10\ \mu\text{m} \times 10\ \mu\text{m}$  was deposited using electron beam. A W tip was manipulated to contact the Pt electrode, and it was connected to the other terminal of the potentiostat, thus completing the mesoscale battery setup. This mesoscale battery was used for in situ observation of Li deposition and cracking in LLZTO. Similar results were obtained when the Li metal electrode was replaced by a layer of InGaAg liquid metal.

As a negative potential was applied to the Pt electrode, a fine-line crack with a closed-loop contour appeared on the top surface of the LLZTO disk (Figure 1b–d; Figure S2, Supporting Information). With the passage of time, Li metal emerged along the crack line and was then extruded out at the LLZTO surface (Figure 1b; Figure S2, Supporting Information). The crack line was widened as more Li extruded until a Li ring was formed on the top surface of the LLZTO disk (Figure 1b–d; Figure S2, Supporting Information). Before battery testing, the grain boundary contours on the LLZTO surface were made visible (Experimental Section), permitting the identification of individual grains (Figure 1b, c; Figure S2, Supporting Information). Interestingly, we found that the cracks were predominantly transgranular (through grains) rather than intergranular (along grain boundaries) (Figure 1c; Figure S2, Supporting Information). Moreover, the entire Li ring was lifted up the LLZTO surface (Figure 1b–d; Figure S2, Movie S1, Supporting Information). To reveal how deep the surface crack ran, a trench perpendicular to the LLZTO top surface was milled out by FIB (Figure 1d, e). To our surprise, a “bowl-shaped” crack was formed underneath the Pt electrode (Figure 1d, e), and such kind of three-dimensional (3D), near-surface crack geometry was highly reproducible. Apparently, the “bowl” was spalled off the LLZTO matrix, as it was entirely lifted up from the LLZTO surface presumably by deposited Li.

To reveal the dynamic formation of the bowl-shaped crack, we pre-milled a trench near the Pt electrode to expose one side surface of the trench (Figure 1f, g). Upon applying a negative potential to the Pt electrode, Li dendrites initially grew at the Pt electrode pad on the LLZTO surface (Figure 1h, i). With increasing potential, a few crack segments emerged and extended on the exposed side surface of the trench (Figure 1g; Movie S2, Supporting Information). By monitoring the evolution of the 3D morphology of two bowl-shaped cracks involved (Figure 1f), we understood the growth processes of these crack segments as follows. At 68 s (Figure 1j), the tip of one bowl-shaped crack (outlined by a blue dotted line) extended into the exposed side surface of the trench and continued to propagate toward its upper left; meanwhile, a branch of another bowl-shaped crack (outlined by a yellow dotted line) emerged near the LLZTO surface. At 212 s (Figure 1k), the first bowl-shaped crack grew longer toward its upper left to merge with the second bowl-shaped crack (Movie S2, Supporting Information). These in situ observations provide evidence of the growth of the bowl-shaped crack from the interior to the top surface of LLZTO. During this process, the crack contour lines on the top surface of the LLZTO disk were widened due to filling of Li metal between the crack flanks (Figure 1j), eventually forming two overlapped Li rings on the LLZTO surface (Figure 1k). Figure S3, Supporting Information provides one more example of the formation of a bowl-shaped crack underneath the Pt electrode. It appears that only a segment of the bowl-shaped crack (Figure S3b, c, left, yellow dotted lines, Supporting Information) reached the LLZTO surface. Once the crack reached the

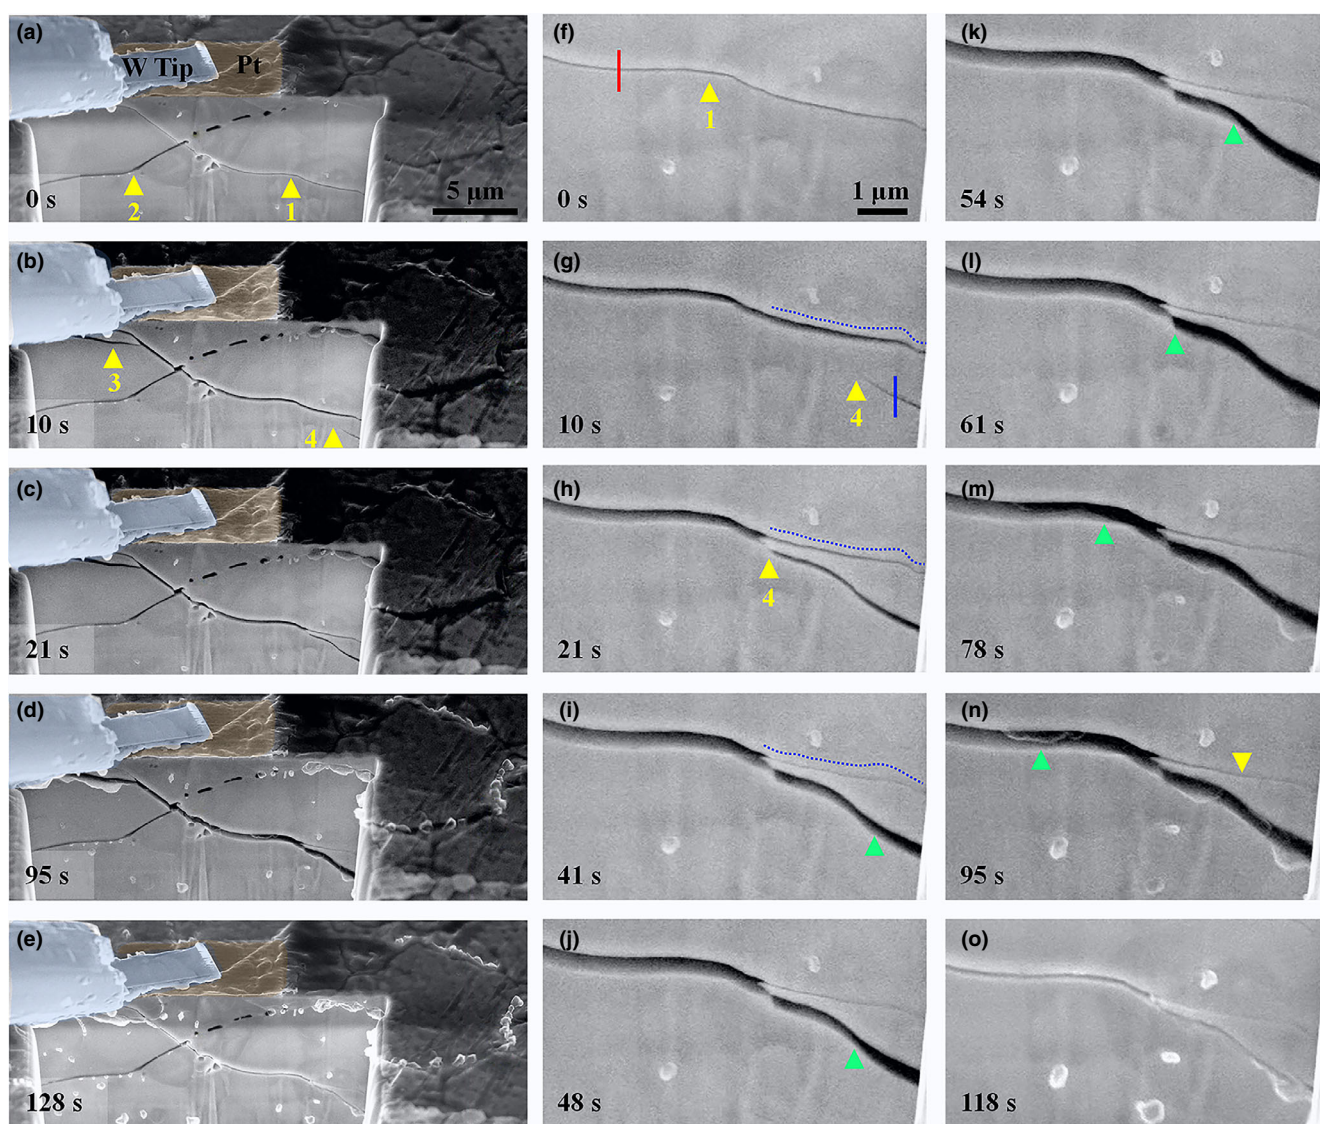
**Figure 2.** In situ observation of the dynamic interplay between crack opening and Li filling in the bowl-shaped crack. a–e) Sequential SEM images showing the dynamic processes of Li filling in a segment of the bowl-shaped crack. f–o) High-magnification SEM images showing Li filling and extracting from the bowl-shaped crack. Note that the crack was widened when Li was filled in between the crack flanks (a–d, f–n), and the crack was closed when Li was extracted (e, o). "1"–"4" mark four different cracks. A green arrowhead indicates the Li moving front in (i–n).

Li filling of the cracks was observed in real time (**Figure 2**; Movie S3, Supporting Information). Figure 2a shows an FIB-milled cross section with two crossing crack segments (denoted as crack 1 and 2). The full profile of the bowl-shaped crack is shown in Figure S4, Supporting Information. With the passage of time, crack 4 extended into the cross section, propagated from the lower right toward the upper left, and merged with crack 1. Subsequently, crack 4 widened (Figure 2b–d, g–n; Movie S3, Supporting Information) as Li was filled in the space between the crack flanks. The Li filling front is marked by a moving green arrowhead in Figure 2i–n. Since crack 1 and 4 were connected, the widening of crack 4 by Li filling also led to the widening of crack 1. As a result, a small crack formed near crack 1 at the upper left corner of the cross section, and this newly formed crack is indicated by an arrowhead and marked as crack 3 in

Figure 2b. Interestingly, as crack 1 and 4 were connected and widened (Figure 2g–n), the lower right segment of crack 1 was closed (marked by a down pointed arrowhead in Figure 2n), likely due to compression caused by the widening of crack 4. The above in situ observations demonstrate that the filled Li between crack flanks can flow and, more importantly, produce sufficiently high internal pressure to cause the formation, widening, and closing of cracks. Upon a reverse potential, crack 1 was closed (Figure 2e, o; Figure S5, Supporting Information). Dendrites that break off will lost contact with the lithium metal anodes and become dead lithium as shown in Figure S6, Supporting Information resulting in the cracks being unable to be healed completely.

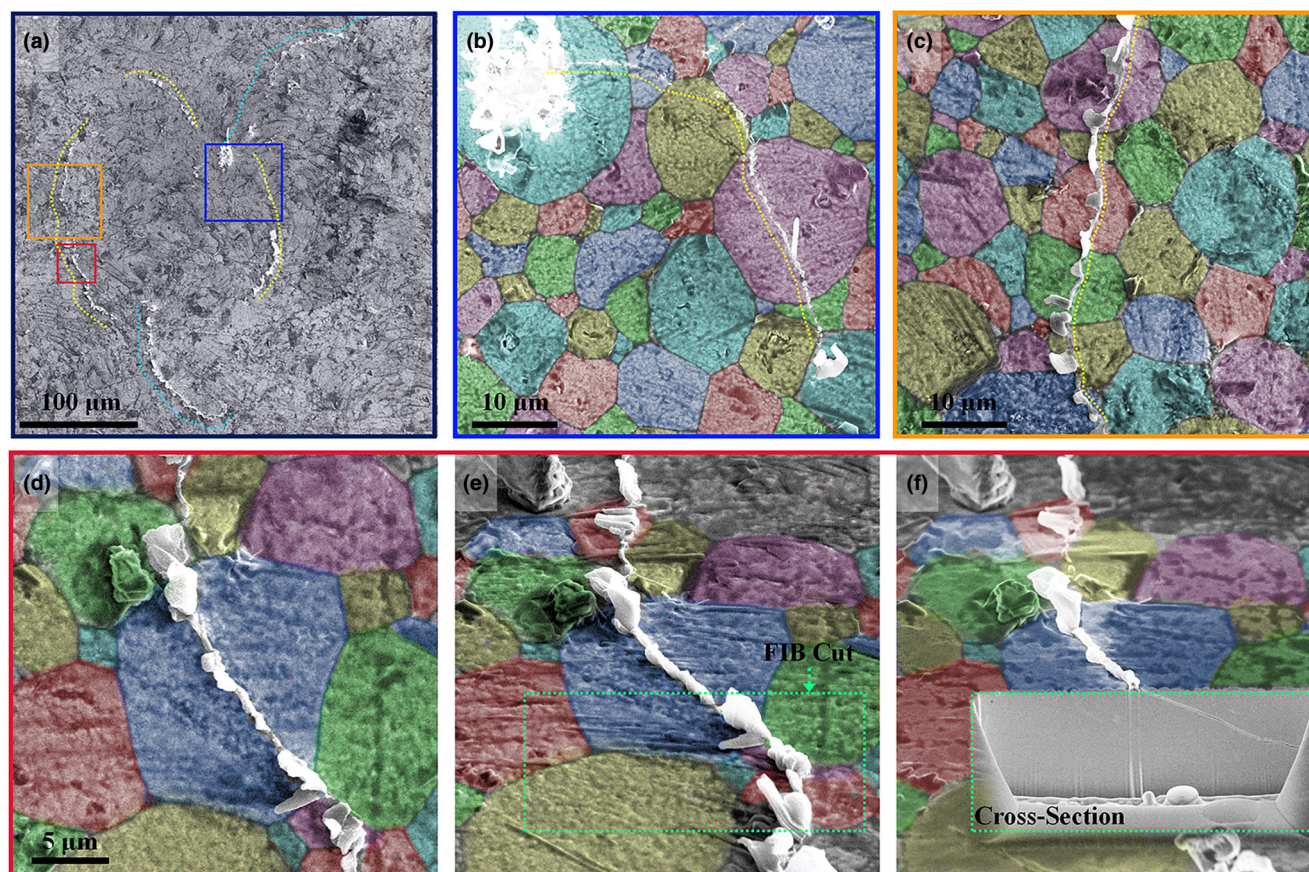
**Figure 3.** SEM images showing Li transpassing LLZTO grains. a–d) Plan view of cracks transpassing grain interiors. a) A full view of the bowl-shaped crack line (outlined by yellow dotted lines) on the top surface of LLZTO. Blue dotted lines outline segments of another bowl-shaped crack. b–f) Magnified view of crack transpassing grain interiors. The false color outlines grains, showing cracks transpassing grain interiors.

By SEM imaging at higher magnification, Li deposition along transgranular cracks became clearly visible (**Figure 3**). Figure 3a shows the

top view of the LLZTO surface where a bowl-shaped crack emerges as a closed-loop crack line (traced by yellow dotted lines) that intersects with another emerging crack line (traced by blue dotted lines) from a different bowl-shaped crack. High-magnification images of the boxed regions in Figure 3a show clearly the surface cracks crossing the interior of a series of grains (Figure 3b–f). The FIB-milled cross section reveals that the surface transgranular crack penetrated into the interior of the LLZTO disk (Figure 3f). The original image of Figure 3 is shown in Figure S7, Supporting Information.

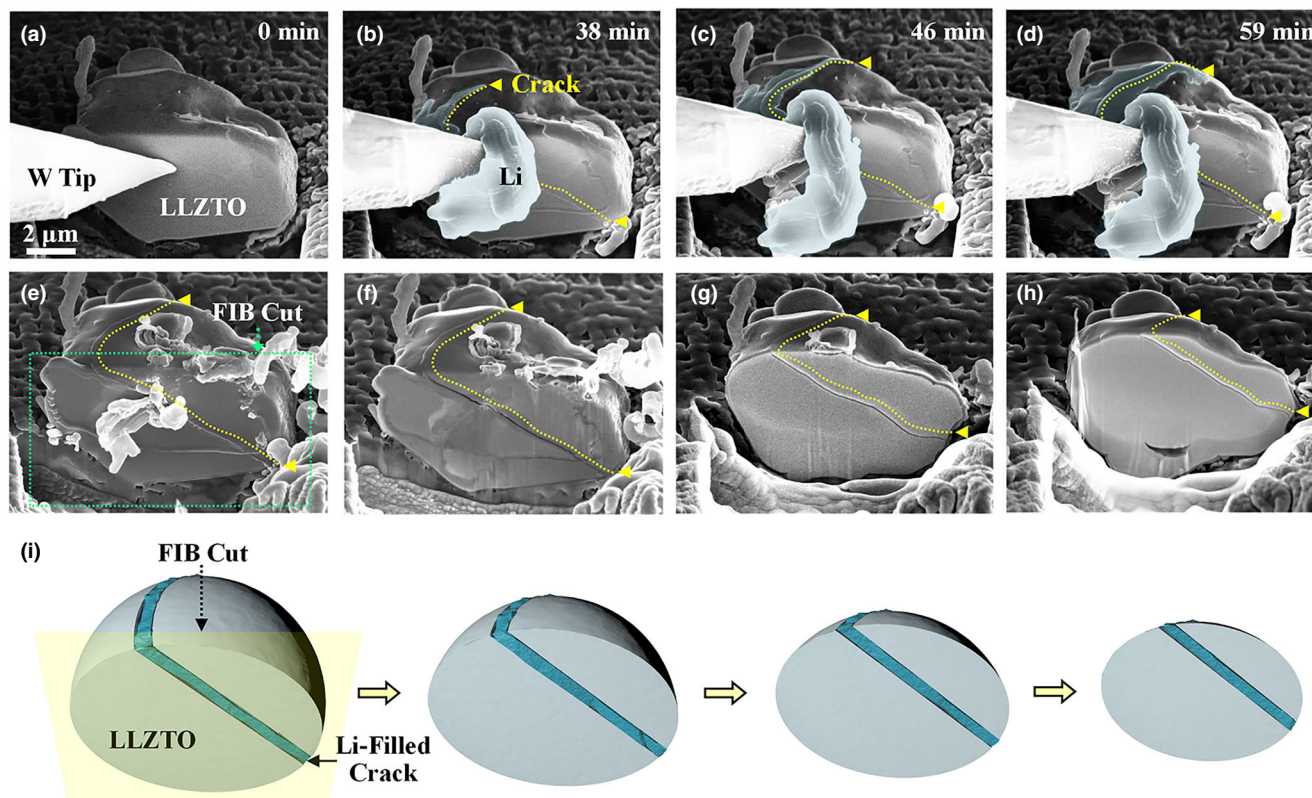
**Figure 4.** Time-lapse SEM images showing crack nucleation and propagation in a single LLZTO grain. a) The initial LLZTO grain with side surface being exposed. b–d) A dendrite and a slanted crack emerged from the LLZTO grain (traced by yellow dotted lines). e–i) Consecutive FIB slicing of the grain showing the crack running from the top to the bottom section of the entire grain, breaking the grain into two pieces. i) Schematic of the slicing process.

To investigate the transgranular fracture induced by Li deposition, we show that cracks can nucleate and propagate in single-crystal LLZTO grains (Figure 4 and Movies S4, S5, Supporting Information). A single-crystal grain was sliced by FIB milling so that a flat side surface was exposed (Figure 4a). Then, the W tip was manipulated to contact this side surface (Figure 4a). When a negative potential was applied to the W tip, a Li dendrite initially grew out under the W tip (Figure 4b). With continued dendrite growth, a slanted crack emerged in the center of the particle (Figure 4b–d, yellow dotted lines), and then, the crack propagated toward the upper-right direction until the grain broke into two parts (Figure 4b–d, Movie S4, Supporting Information). Consecutive FIB slicing along the side surface indicates that the crack crossed through the entire grain (Figure 4e–i, Movie S5, Supporting Information).

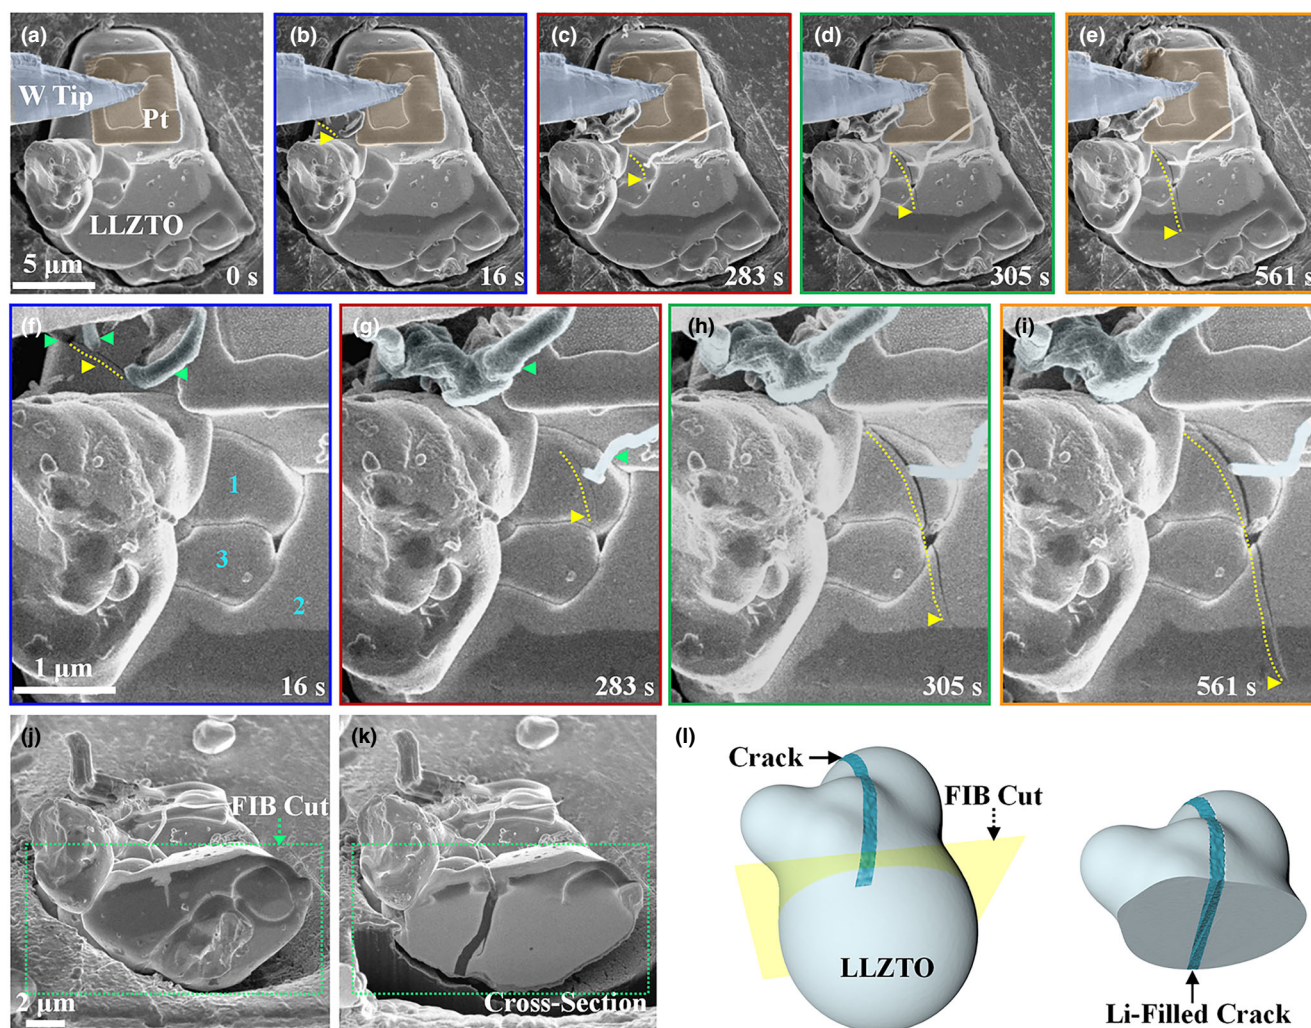
**Figure 5.** Time-lapse SEM images showing crack nucleation and propagation in an LLZTO particle comprising multiple grains. a) The initial LLZTO grain. b–e) Nucleation and propagation of a crack. f–i) Magnified view of the corresponding image in (b–e) enclosed by the box of same color, showing the crack propagation. Three grains are marked by 1–3 in (f). The crack transpassing grains 1–3 is indicated by a yellow dotted line and the crack tip by a yellow arrowhead. j–l) FIB slicing showing the crack transverse from the top to the bottom of the grain. l) Schematic showing cracking of the LLZTO grain.

We further show that a crack can cross through two neighboring grains continuously in a multi-grained LLZTO particle (Figure 5a–i). The particle comprised at least three grains with grain boundaries and cavities (Figure 5a–i). We made a Pt electrode pad on top of the particle (Figure 5a). Upon applying a negative potential to the Pt electrode, three Li dendrites appeared at the edge of the contact pad (indicated by three green arrowheads in Figure 5f). At 283 s, another slim dendrite emerged accompanying the formation of a microcrack in grain 1 (Figure 5c, g). The crack was neither stopped nor deflected by the grain boundaries; instead, it crossed directly into grain 2 and then propagated downward through grain 2 (Figure 5c–e, g–i, Movie S6, Supporting Information). We milled the particle to expose its side surface, which showed that the crack ran through the entire particle, breaking the particle into two parts (Figure 5j–l; Movie S7, Supporting Information).

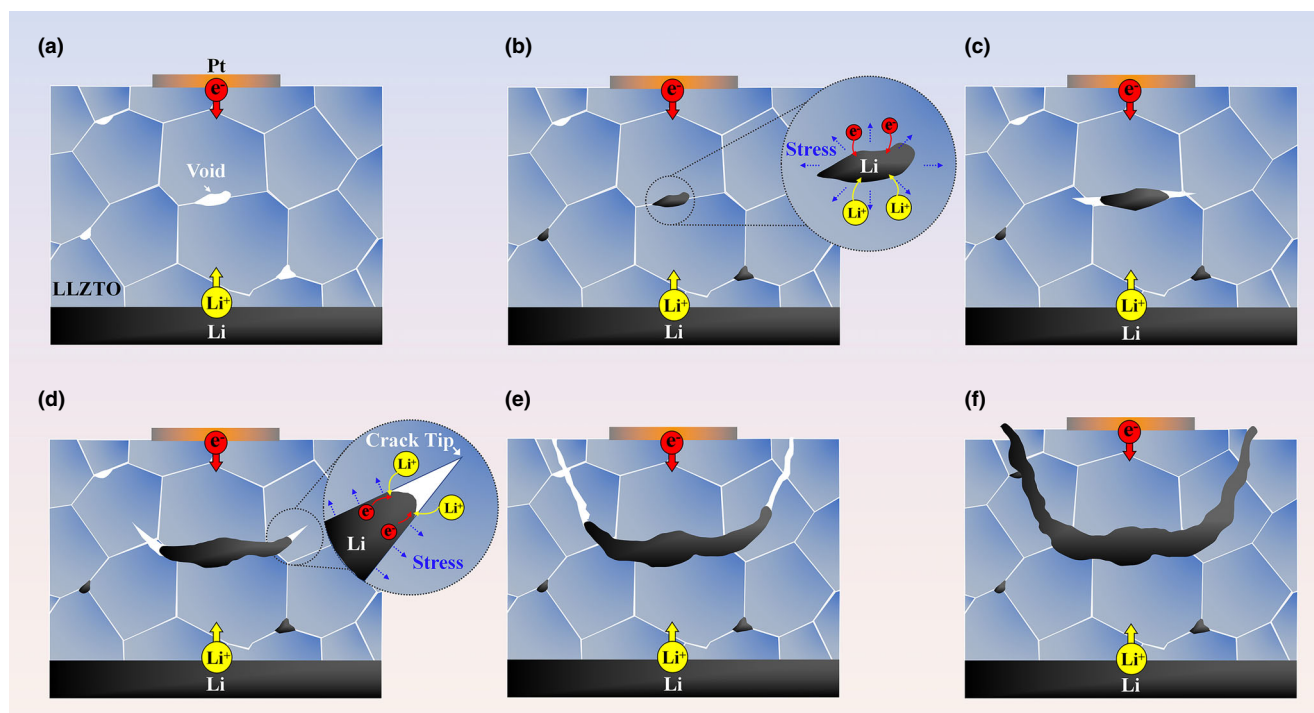
**Figure 6.** Schematic illustration of the formation mechanism of the bowl-shaped crack. a–c) Li deposition initiates at internal defects such as voids (a, b), generating high pressure in Li-filled defects, causing crack nucleation and propagation and then continued Li filling in between the crack flanks behind the running crack front (b–c). The filled Li is constrained by the crack flanks, producing wedging stresses to drive the crack propagation (d). Due to surface attraction, the running crack curves toward the free surface, resulting in a bowl-shaped crack (d, e), and a chunk of LLZTO spalled off and was lifted up by filled Li in the bowl-shaped crack (f).

Based on the above in situ observations, we envision the following mechanisms of Li deposition-induced nucleation and growth of bowl-shaped cracks (Figure 6a–f). As a sufficiently large negative potential was applied to the Pt electrode, significant Li deposition took place underneath the Pt electrode pad, presumably at favored internal defects such as voids or grain boundaries (Figure 6a, b). These voids may include intragranular voids, not just those between grains. We used FIB to slice single-crystal LLZTO grains and found that almost all of them

contain microscale voids (Figure S8; Movie S8, Supporting Information). Electrons needed for the reduction of Li ions are likely available due to the small, but finite electrical conductivity of LLZTO.<sup>[14]</sup> Li deposition could be enhanced by the elevated electric field near the Pt electrode that promoted electron flow. Li deposition was self-amplified due to increased electronic conductivity at these Li deposition sites. Under the mechanical confinement of the surrounding LLZTO, continued Li deposition leads to the buildup of large internal pressure, triggering the nucleation of an internal crack through the expansion of a Li-filled defect.
